Manhole Inspection Summary

Manhole # S51CC_003MH

Location Address: **2812 e madison st**

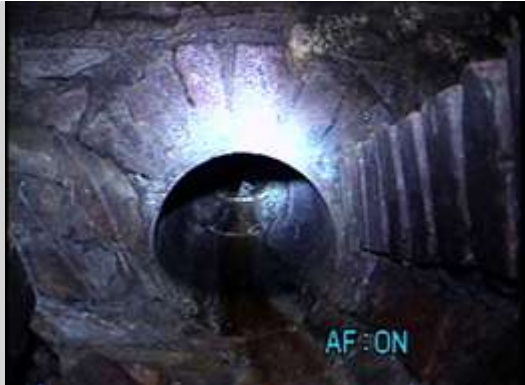
12 O'Clock Outflow

8 in. Circular Gravity Sewer
Pipe Out @ 12 O'Clock

Pipe Material: **Clay** ☐ Pipe Lined

Invert Depth: **9.16** (ft.) Flow Characteristics: **Fast**

Infiltration: **None** Pipe Seal Cond: **Unknown**

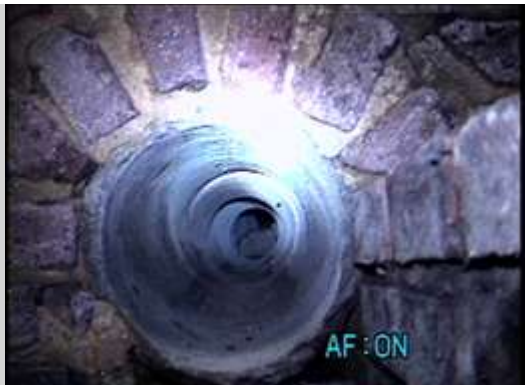
1 O'Clock Inflow

8 in. Circular Gravity Sewer
Pipe In @ 1 O'Clock

Pipe Material: **Clay** ☐ Pipe Lined

Invert Depth: **8.66** (ft.) Flow Characteristics: **None**

Infiltration: **None** Pipe Seal Cond: **Unknown**

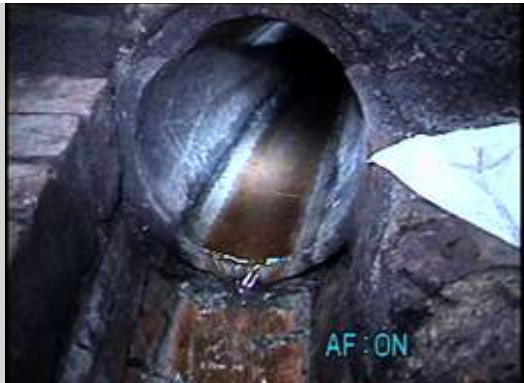
7 O'Clock Inflow

Pipe In @ 7 O'Clock

Pipe Material: **Clay** ☐ Pipe Lined

Invert Depth: **8.16** (ft.) Flow Characteristics: **Fast**

Infiltration: **None** Pipe Seal Cond: **Unknown**

Connects To: **Dead End**

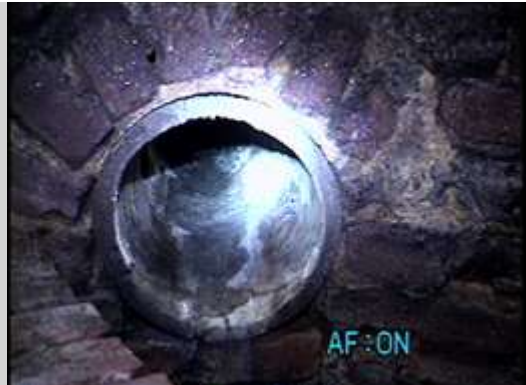
10 O'Clock Inflow

Pipe In @ 10 O'Clock

Pipe Material: **Clay** ☐ Pipe Lined

Infiltration: **None** Pipe Seal Cond: **Unknown**
